**AN EXCELLENT IMPRESSION**

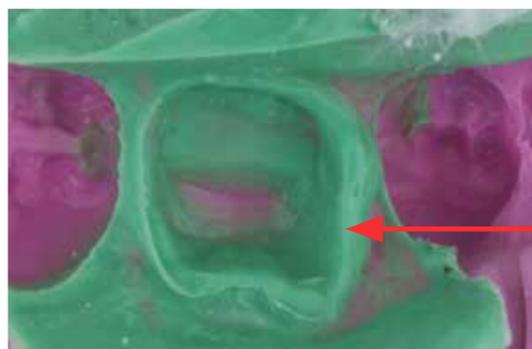
**INADEQUATE MARGINS**

**Probable Causes:**

- Incomplete sulcular expansion around the preparation
- Improper moisture control around the preparation
- Exceeding the material's working time
- Tray movement after seating

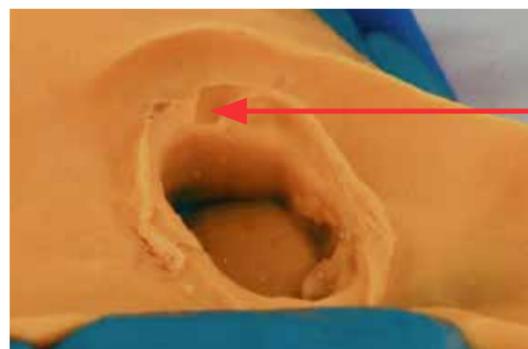
**VOIDS**

**Probable Causes:**

- Improper syringe technique
- Sulcular fluid/bloods/contaminants
- Incomplete sulcular expansion around the preparation
- Tray incorrectly seated
- Insufficient preparation covered by the impression material

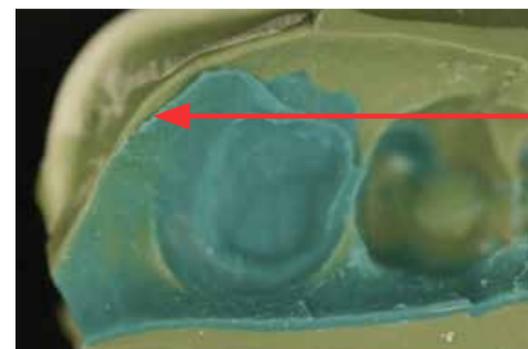
**DEBONDING**

**Probable Causes:**

- Exceeding the material's working time
- Contamination of tray material
- Impression material stored at a temperature above manufacturer's recommendation

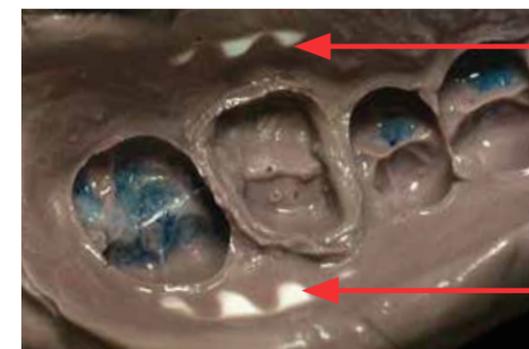
**TRAY CONTACT**

**Probable Causes:**

- Incorrect tray size used
- Tray not oriented correctly
- Insufficient impression material used

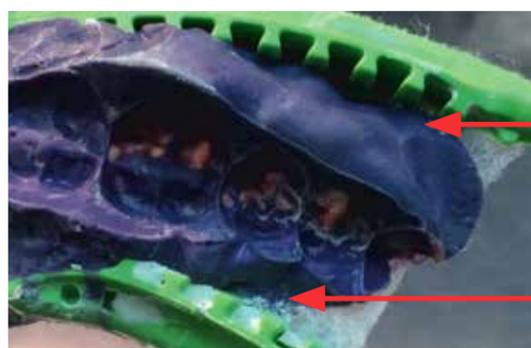
**INADEQUATE IMPRESSION RETENTION**

**Probable Causes:**

- Insufficient impression material used
- No tray adhesive used
- Inadequate tray adhesive drying time
- Outdated impression material used

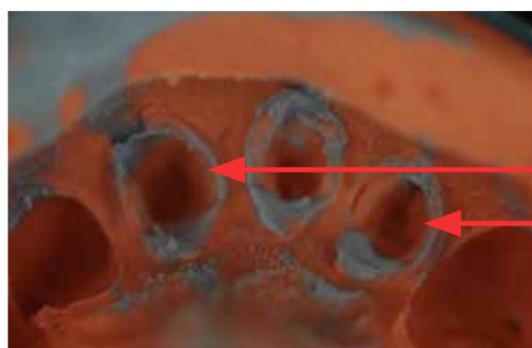
**TEARING OF WASH MATERIAL**

**Probable Causes:**

- Insufficient retraction around the preparation
- Impression removed before material has set
- Improper moisture control around the preparation
- Outdated impression material us

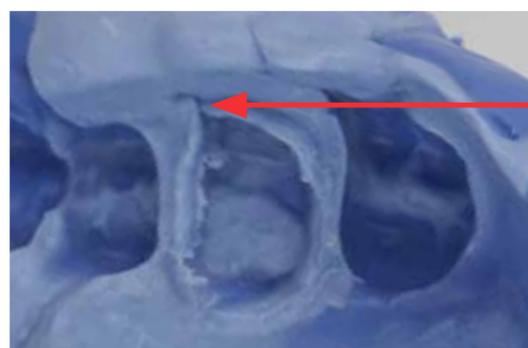
**PULLS**

**Probable Causes:**

- Exceeding the material's working time
- Tray movement after seating the impression
- Insufficient impression material used
- Rapid seating of the impression tray

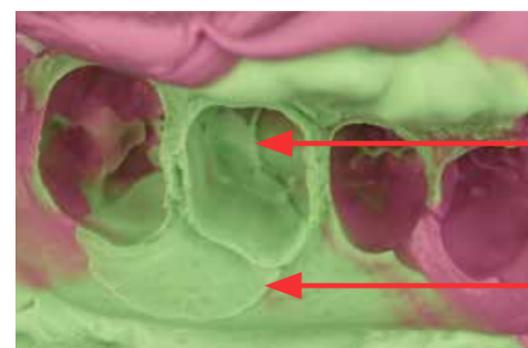
**LEDGES**

**Probable Causes:**

- Preparation of most posterior tooth is contraindicated with dual-arch trays
- Buccal, lingual and posterior tray contact
- Lack of occlusal clearance
- Extreme mesh exposure

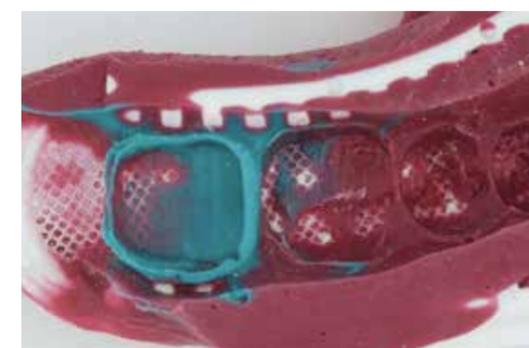
**TRAY ISSUES**

**Probable Causes:**

- Incomplete sulcular expansion around the preparation
- Improper moisture control around the preparation
- Exceeding the material's working time
- Tray movement after seating
